# Funding Reserve Analysis

## Mt. Baker Rim Community Club Level 1 Study 2021

May 07, 2021

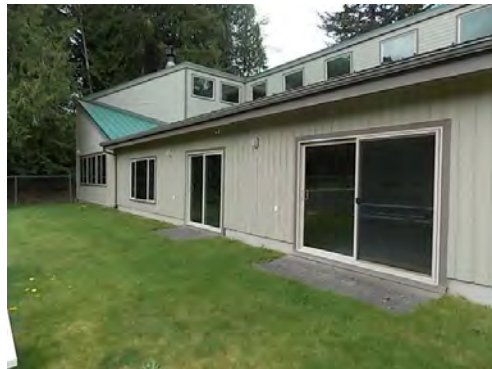
**Clubhouse - Siding Replacement - 2023**

The clubhouse has had several areas where the siding has been replaced with a cement fibrous lap siding product over the last few years. There are sections that remain that will require inspection and repair of reported rot damage within the wall structure prior to replacement of the existing with new lap siding.

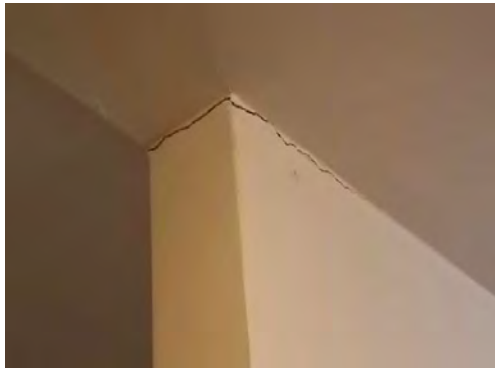
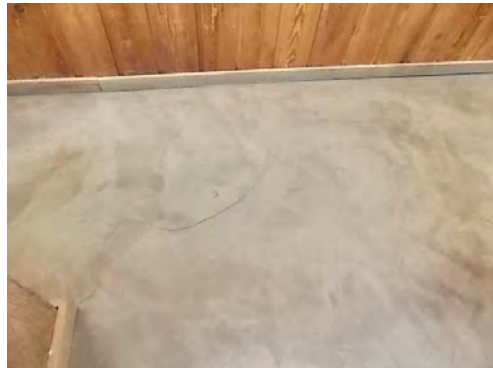
**Clubhouse - Engineer Evaluation - 2021**

Our understanding is there are ongoing issues in the clubhouse with sinking floors and the resulting cracks in the walls due to historical drainage issues. The floors have been repaired in past years however settling and cracks have returned. We recommend consultation with a professional engineering company for a full evaluation of the causes and recommendations on permanent solutions.

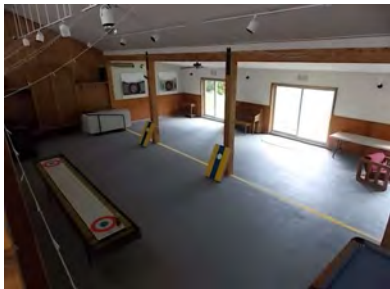
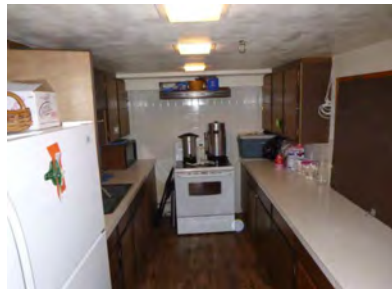
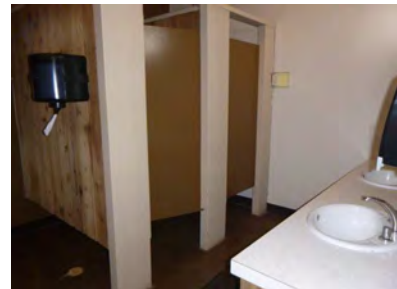
**Clubhouse Interior Refurbish - 2025**

Funds are included for refurbishing the interior of the clubhouse common areas, restrooms and kitchen.

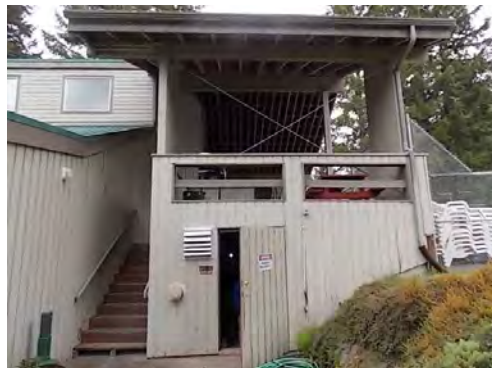
**Clubhouse - Decking & Fencing - 2025**

The clubhouse exterior deck area was updated last in 1995. Funds are included for future updating the deck and fence areas.

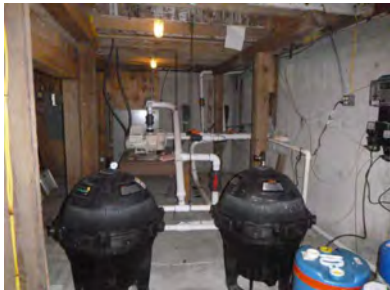
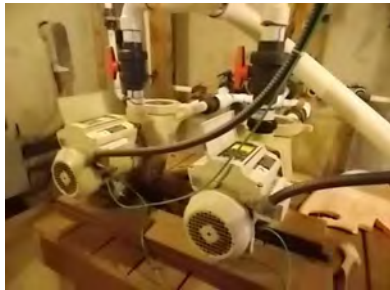
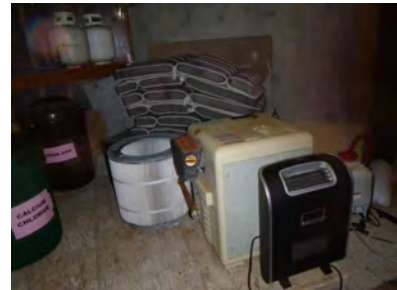
**Pool - Equipment Major Repair & Replacement - 2029**

The budget includes funds for replacement of the various pool equipment.

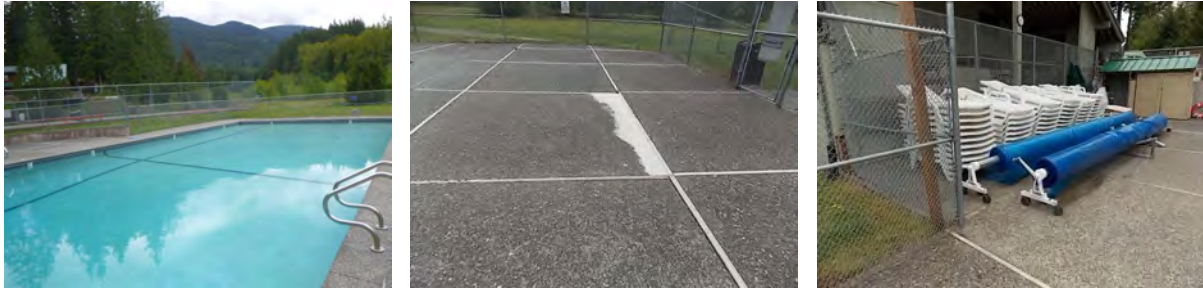
*Pool - Interior & Deck Surfaces continued...*

Our understanding is the pool interior was last resurfaced in 2011. There have been some tiles that have come loose and some hollow areas found behind other tiles. The pool deck surface will also require replacement or major repair work as the existing concrete squares are shifting which causes trip hazards and constant adjustment of the wood expansion joint materials. The budget includes a placeholder estimate for this project.

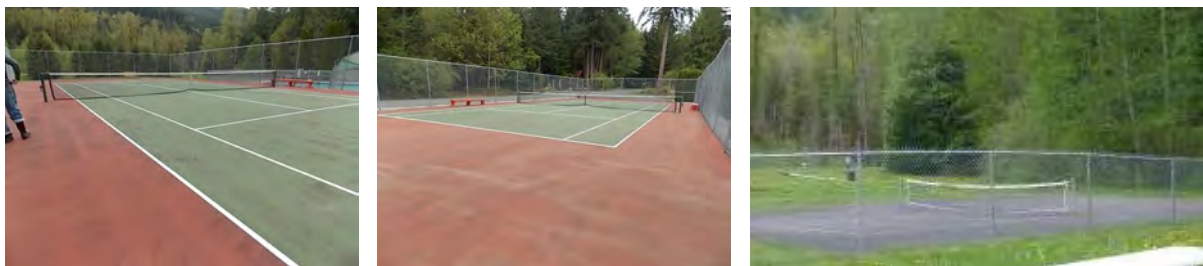
**Tennis Court Maintenance & Surface Replacement - 2030**

It was reported the tennis courts were resurfaced in 2008 and continue to appear in good condition. Funds are included for maintenance, future resurfacing and fence repair as may be required.

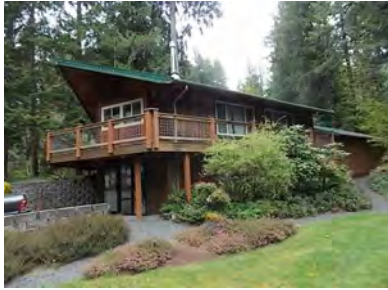
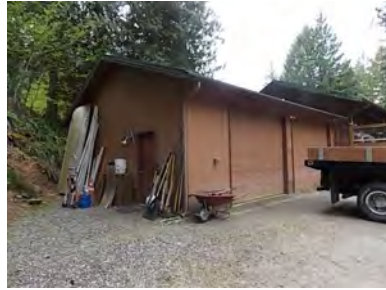
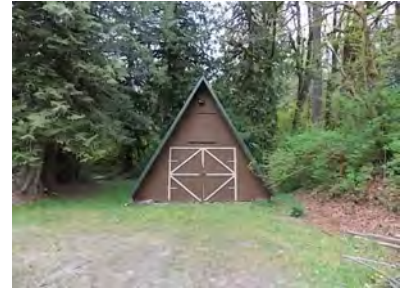
**Gate House, Garage, A-Frame Exterior Maintenance & Repair - 2021**

Funds are included annually for exterior maintenance, repair and painting/staining of the gate house & deck, garage and a-frame as required. All appear to be well maintained and in good condition currently.

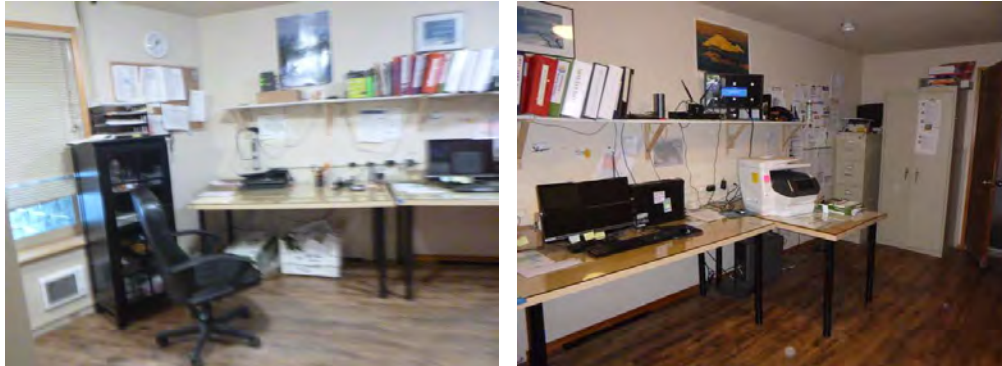
*Gate House & Manager Apartment Interior Refurbish continued...*

The interiors of the gate house office area and manager apartment have been updated over the years by staff. Funds are included for future refurbishing in 10 year cycles.

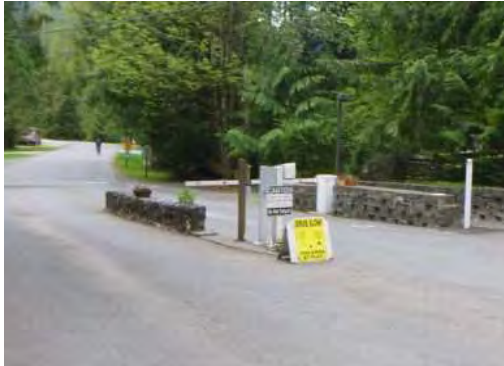
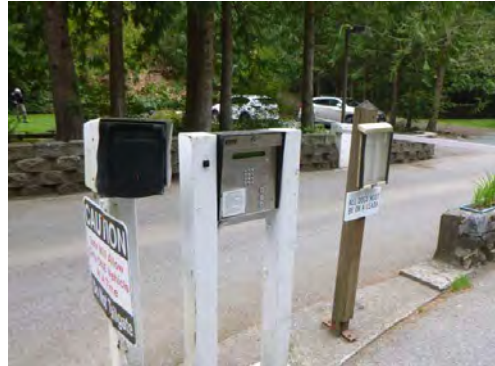
*Gate Entry System continued...*

Funds are included for the community gate entry system which requires significant maintenance and replacement in future years.

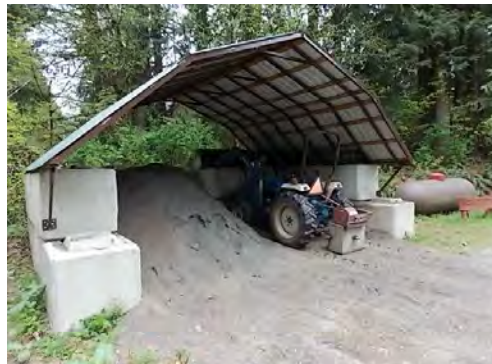
**Ford Tractor - 2025**

Plans call for purchase of a newer and larger tractor in the next few years as the current model is

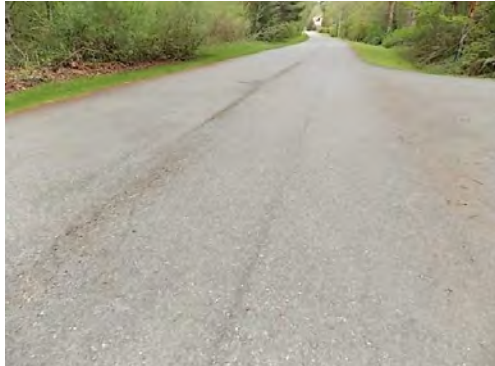
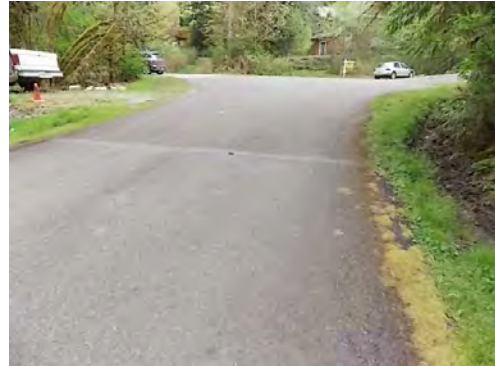
**Road Major Repair - 2022**

The community owns and maintains several miles of internal asphalt paved roads. Minor repair is carried out annually by staff members. Approximately every three years a commercial paving company is contracted to make major repairs.

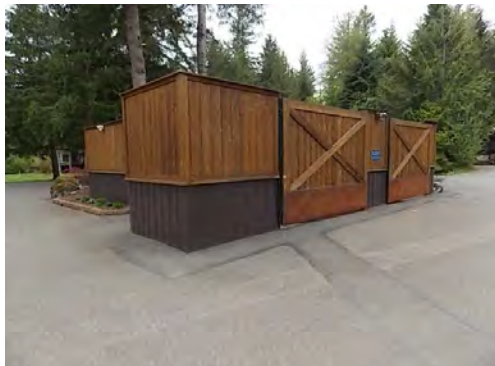
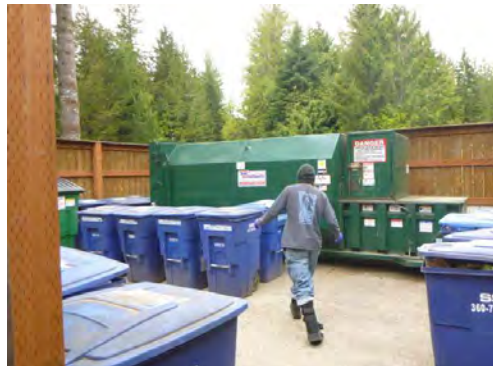
**Trash Enclosure & Compactor Maintenance - 2030**

Funds are included for maintaining the trash enclosure and compacting equipment.

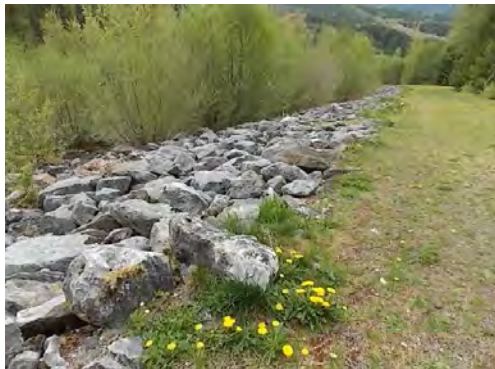
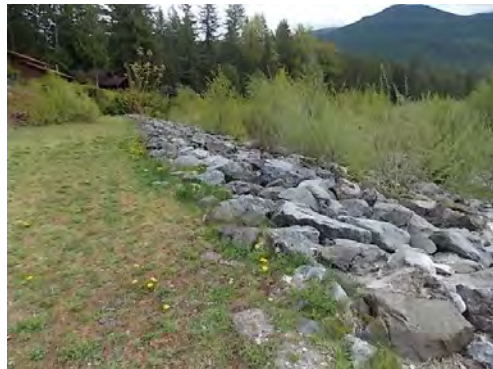
**Dike Repair & Maintenance - 2022**

The dike along the river requires ongoing inspection, maintenance and occasional repair.
