# Funding Reserve Analysis

## Mt. Baker Rim Community Club Level 1 Study 2021

May 07, 2021

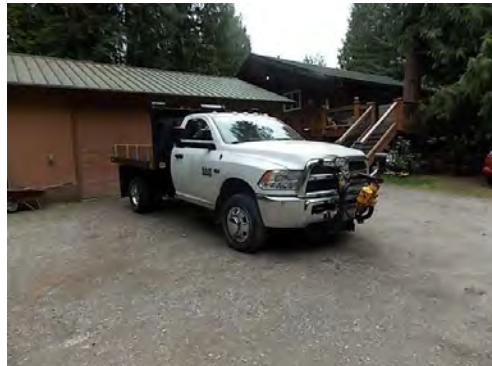
Asset ID	1016
Vehicles & Equipment	
Placed in Service	January 2016
Useful Life	15
Replacement Year	2031
Remaining Life	10

1 Allowance	@ \$40,000.00
Asset Actual Cost	\$40,000.00
Percent Replacement	100%
Future Cost	\$53,756.65

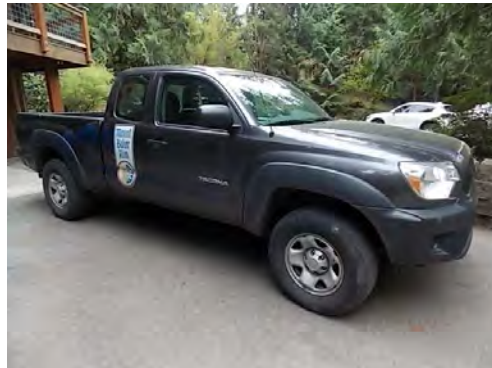
**Toyota Tacoma Pickup - 2030**

Asset ID	1017	1 Allowance @	\$30,000.00
		Asset Actual Cost	\$30,000.00
		Percent Replacement	100%
		Future Cost	\$39,143.20
Vehicles & Equipment			
Placed in Service	January 2012		
Useful Life	15		
Adjustment	3		
Replacement Year	2030		
Remaining Life	9

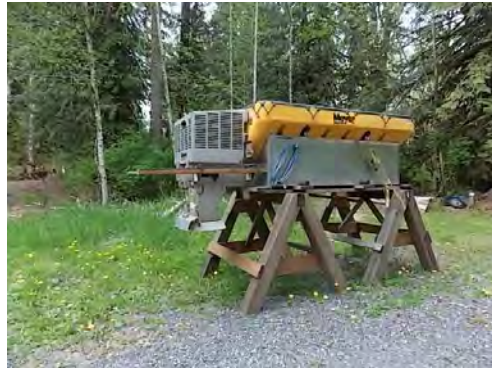
**Sander/Spreader - 2025**

Asset ID	1019	1 Allowance	@ \$5,000.00
		Asset Actual Cost	\$5,000.00
		Percent Replacement	100%
		Future Cost	\$5,627.54
Vehicles & Equipment			
Placed in Service	January 2011		
Useful Life	10		
Adjustment	4		
Replacement Year	2025		
Remaining Life	4
